# LXT971A/972A PHY Transceivers

## Specification Update

Order Number: **249354-007**

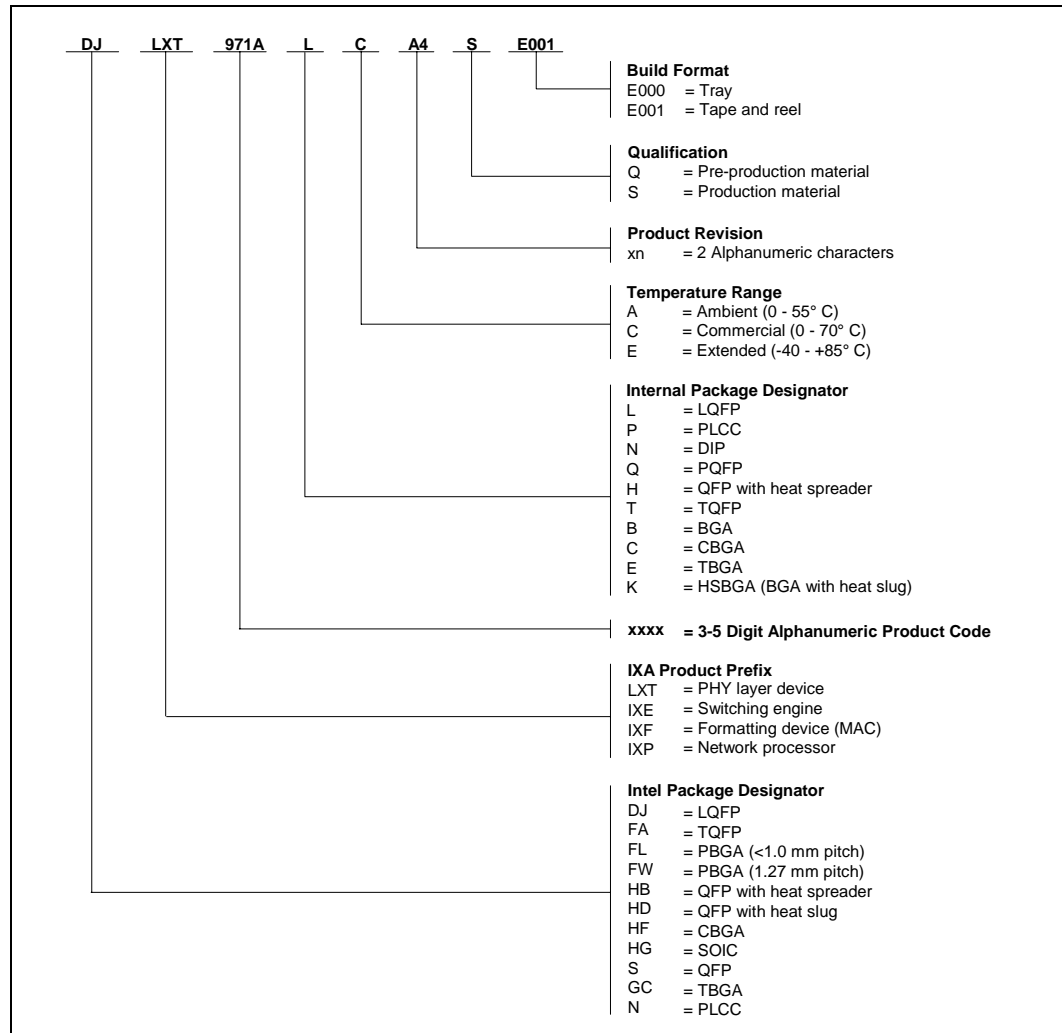
**Figure 1. Ordering Information - Sample**

Number	Revision	Qualification	Tray MM	Tape & Reel MM
DJLXT971ALC.A4	A4	S	834105	834916
DJLXT971ALE.A4	A4	S	835676	835791
FLLXT971ABC.A4	A4	S	834103	834926
FLLXT971ABE.A4	A4	S	834104	835080
DJLXT972ALC.A4	A4	S	834109	834917
